Facility Category: Public Services
Facility Age (Yrs): 135
Year Built: 1889
Total Square Footage: 4,451
Date(s) of Assessment: 4/9/2024

City Hall
 20 E Main St, Ashland, OR 97520

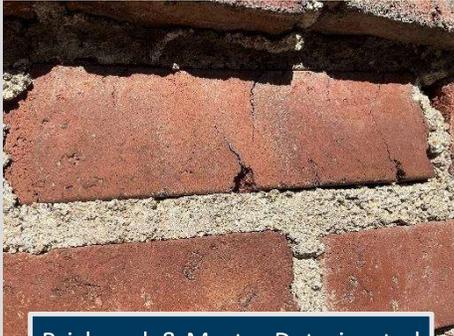
The building envelope exhibits significant structural deficiencies, including failures in the brickwork and mortar. Additionally, the roofing has exceeded its useful life, and windows installed across different decades require attention. Comprehensive repairs and replacements are essential to maintain the integrity and functionality of the building envelope.

Brickwork & Mortar Deteriorated

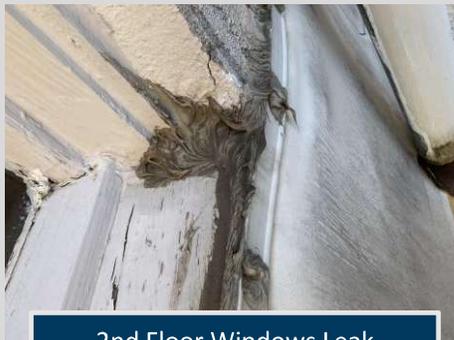
2nd Floor Windows Leak

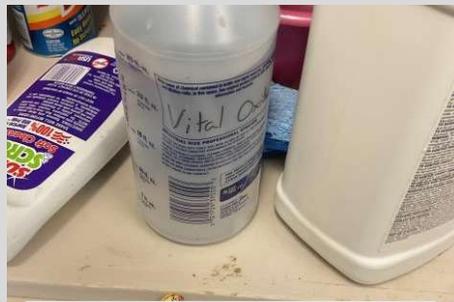
Secondary Use Label Missing (OSHA)

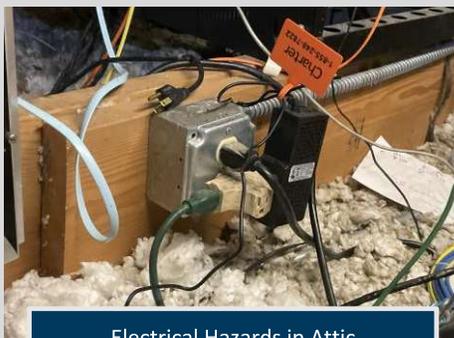
Electrical Hazards in Attic
